HISTORIC PROPERTIES REPORT

PUEBLO DEPOT ACTIVITY

PUEBLO, COLORADO

FINAL REPORT

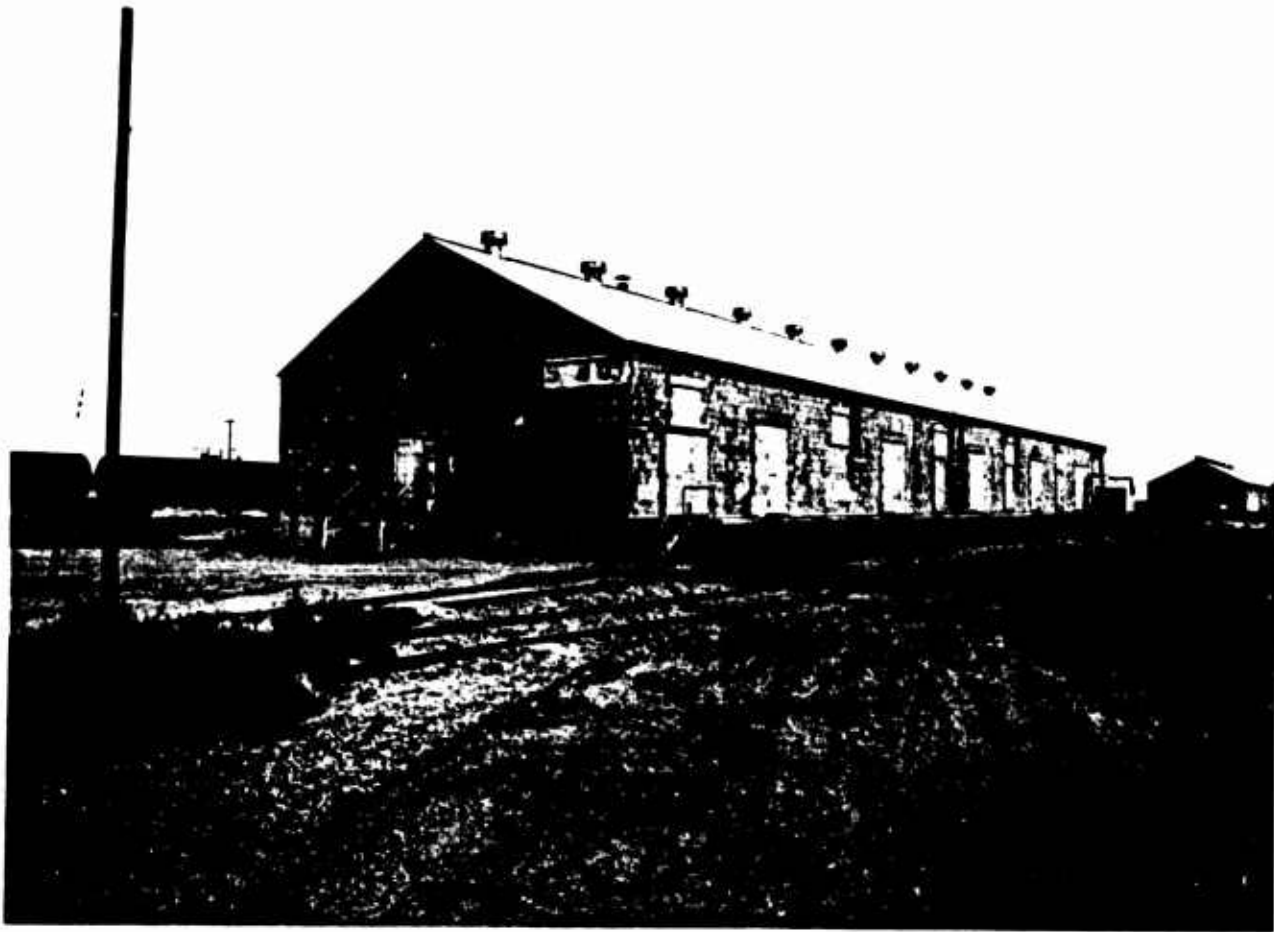
Figure 5: Building 761 is representative of the installation's twelve above-ground magazines that were converted to ammunition renovation workshops in the early 1950s. (Source: Field inventory photograph, 1983, Jeffrey A. Hess, MacDonald and Mack Partnership.)

Except for a block of twelve, standard, above-ground, clay-tile magazines (Buildings 701, 706, 711, 716, 731, 736, 741, 746, 761, 766, 771, 776) (Figure 5) in the southeast corner of the igloo area, the remainder of the depot's principal buildings were located in the southern quarter of the installation.<sup>9</sup> These structures formed two major groupings: an administration-and-maintenance area to the west, and a warehouse-and-shop area to the east (Figures 6, 7). The utilitarian-style architecture of both areas reflected the Army's general wartime construction policy for depots: "The first consideration was economy in money, time, and critical materials."<sup>10</sup> PUDA's administration-and-shop area, for example, made

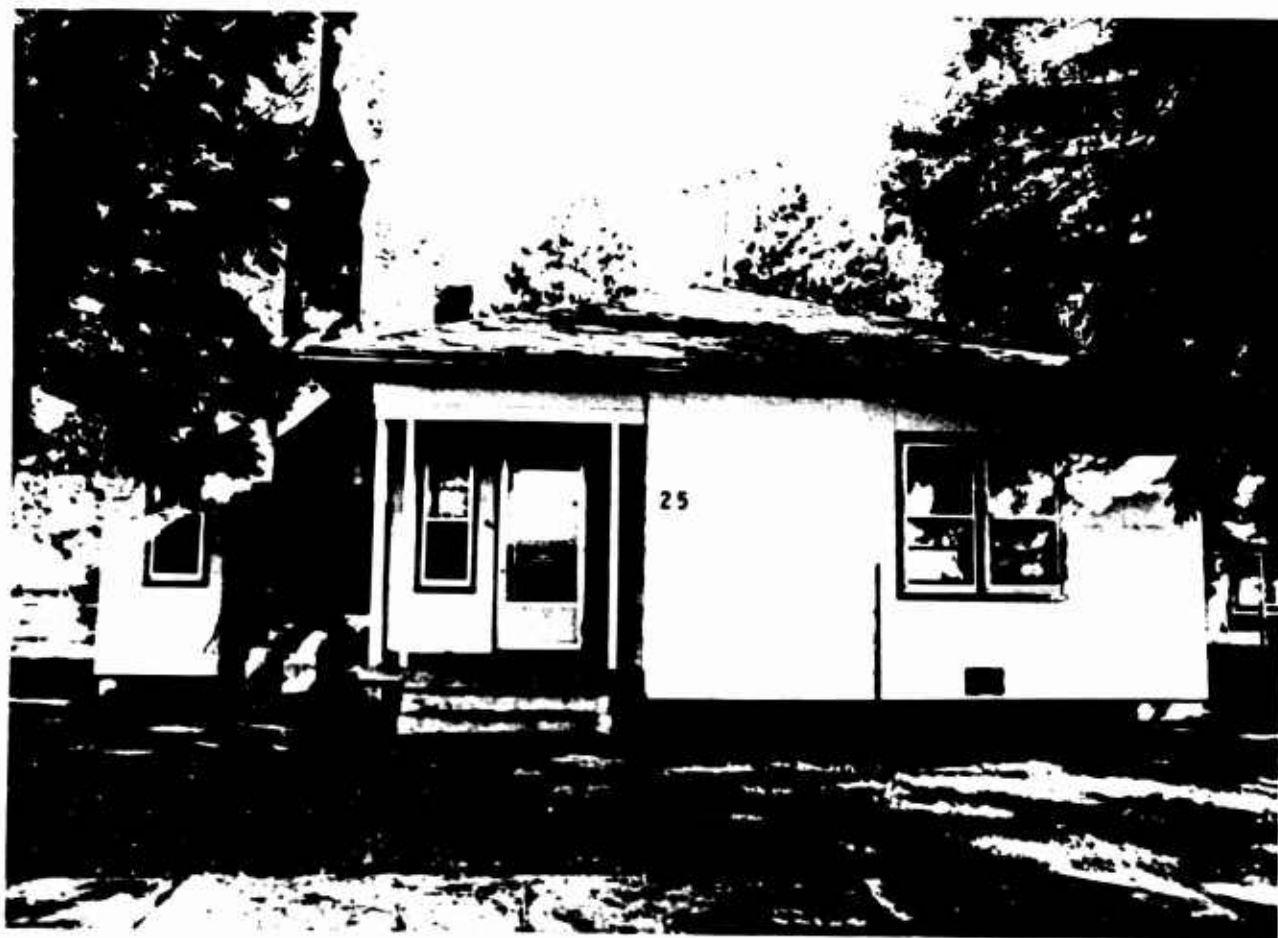
Figure 11: Building S25 is typical of the five houses built for staff officers in 1942-1943. (Source: Field inventory photograph, 1983 Jeffrey A. Hess, MacDonald and Mack Partnership.)

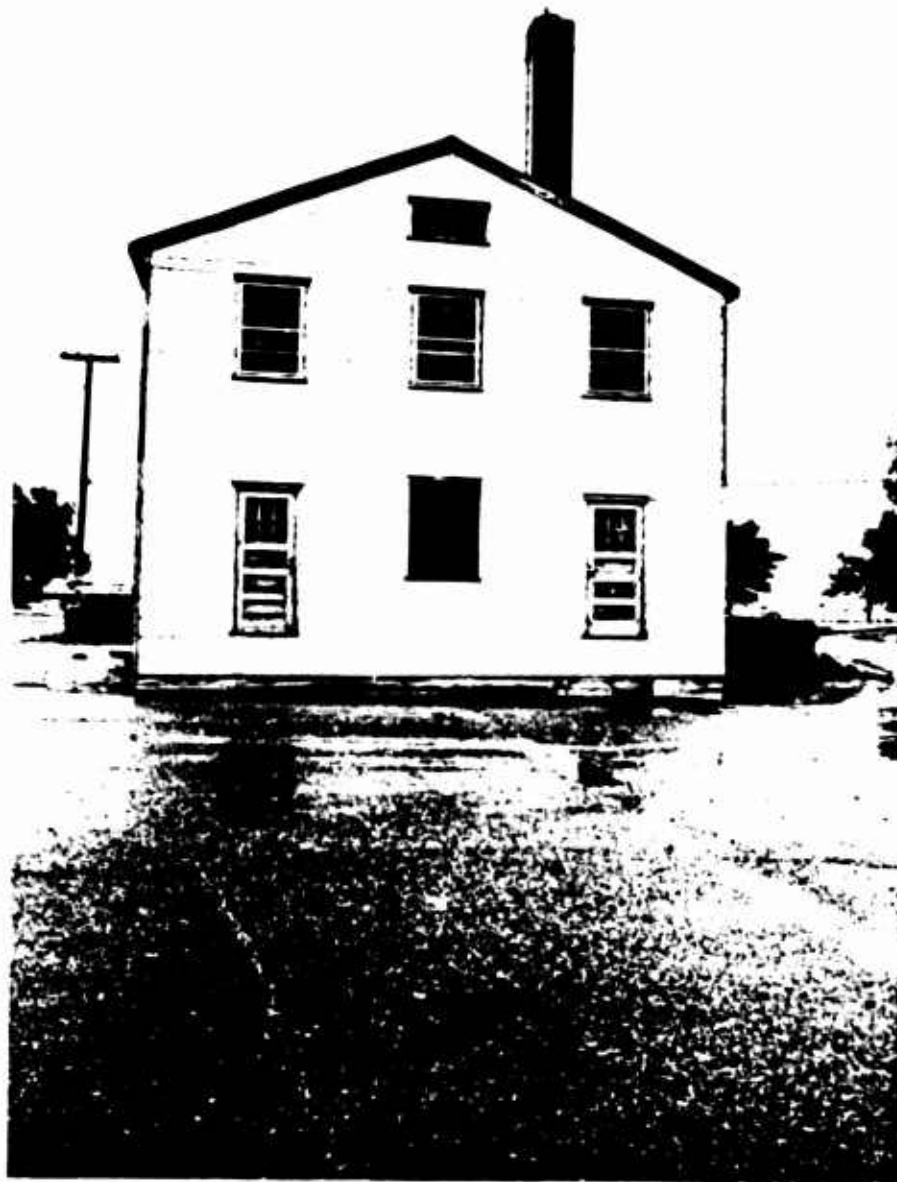
Figure 12: Building T125 is representative of the officers' barracks built at the depot in 1942-1943. (Source: Field inventory photograph, 1983, Jeffrey A. Hess, MacDonald and Mack Partnership.)

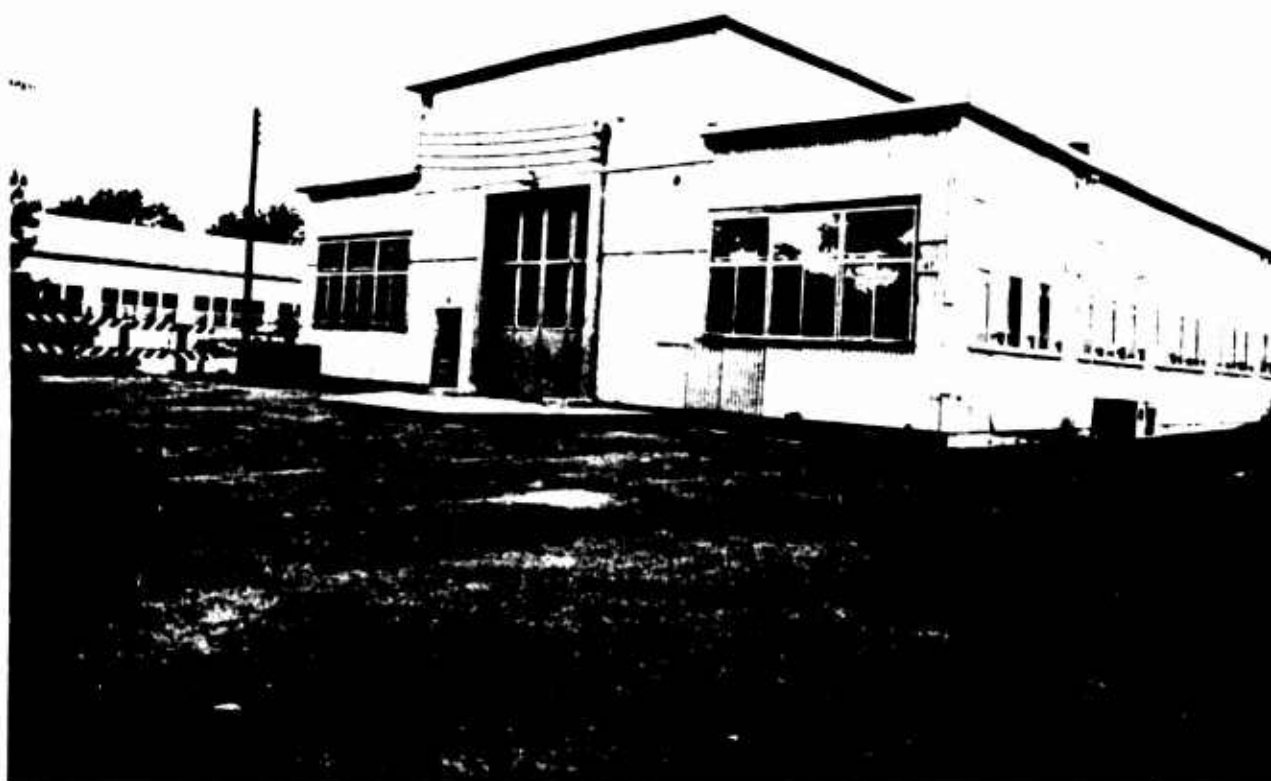
Figure 13: Originally constructed as a machine shop, Building S47 now serves as a roads and grounds facility. (Source: Field inventory photograph, 1983, Jeffrey A. Hess, MacDonald and Mack Partnership.)

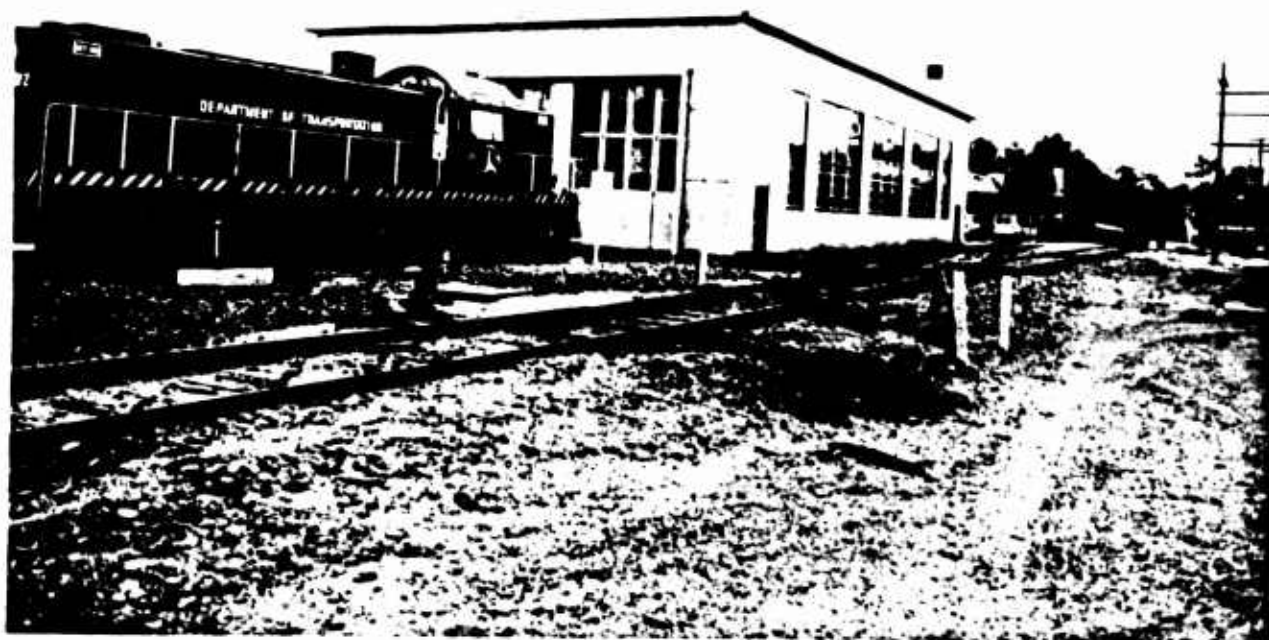
Figure 14: Locomotive Repair Shop (Building S67). (Source: Field Inventory photograph, 1983, Jeffrey A. Hess, MacDonald and Mack Partnership.)

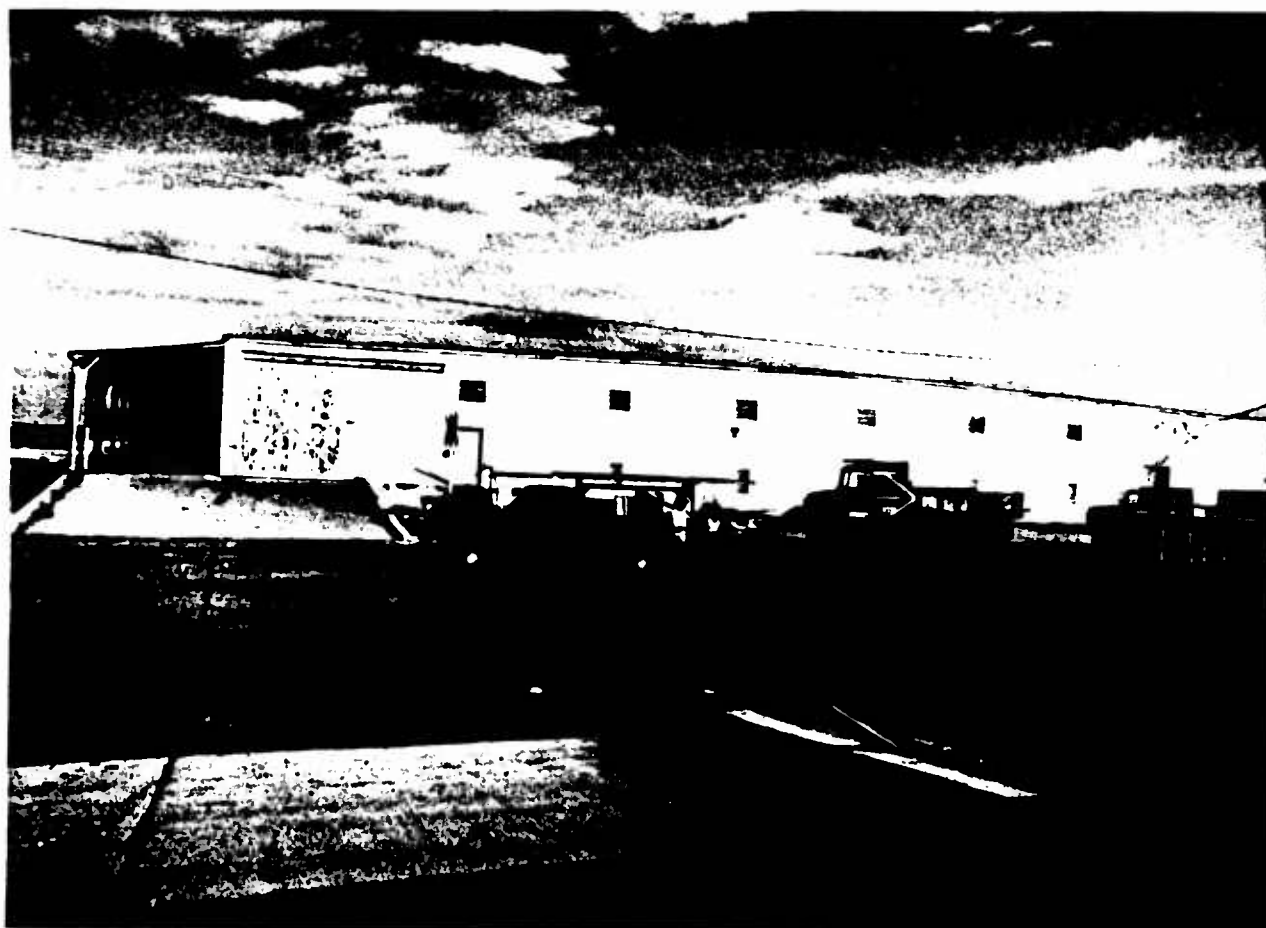
Figure 16: Building 555 is representative of the wood-frame, clay-tile warehouses constructed at the depot in 1942-1943. (Source: Field inventory photograph, 1983, Jeffrey A. Hess, MacDonald and Mack Partnership.)

Facilities in the warehouse-and-shop area were designed to store and repair a variety of military supplies, including combat vehicles. Following general wartime specifications for depots, "warehouses [Buildings 525-528, 541-544, 552-555] [Figures 15, 16] were . . . of light frame construction, with fire walls only where necessary, with roofing specifications not to exceed a 10-year limit, and without excessive roof spans; sheds [Buildings S575-S578, S580-S584, S590-S594] [Figure 17] were . . . of open-type light frame construction without concrete floors."<sup>12</sup> The most durable structures in this area of the depot were four ordnance repair shops (Buildings 547, 548, 550, 551) (Figures 18, 19), which exhibited steel framing and corrugated-metal siding and roofing.

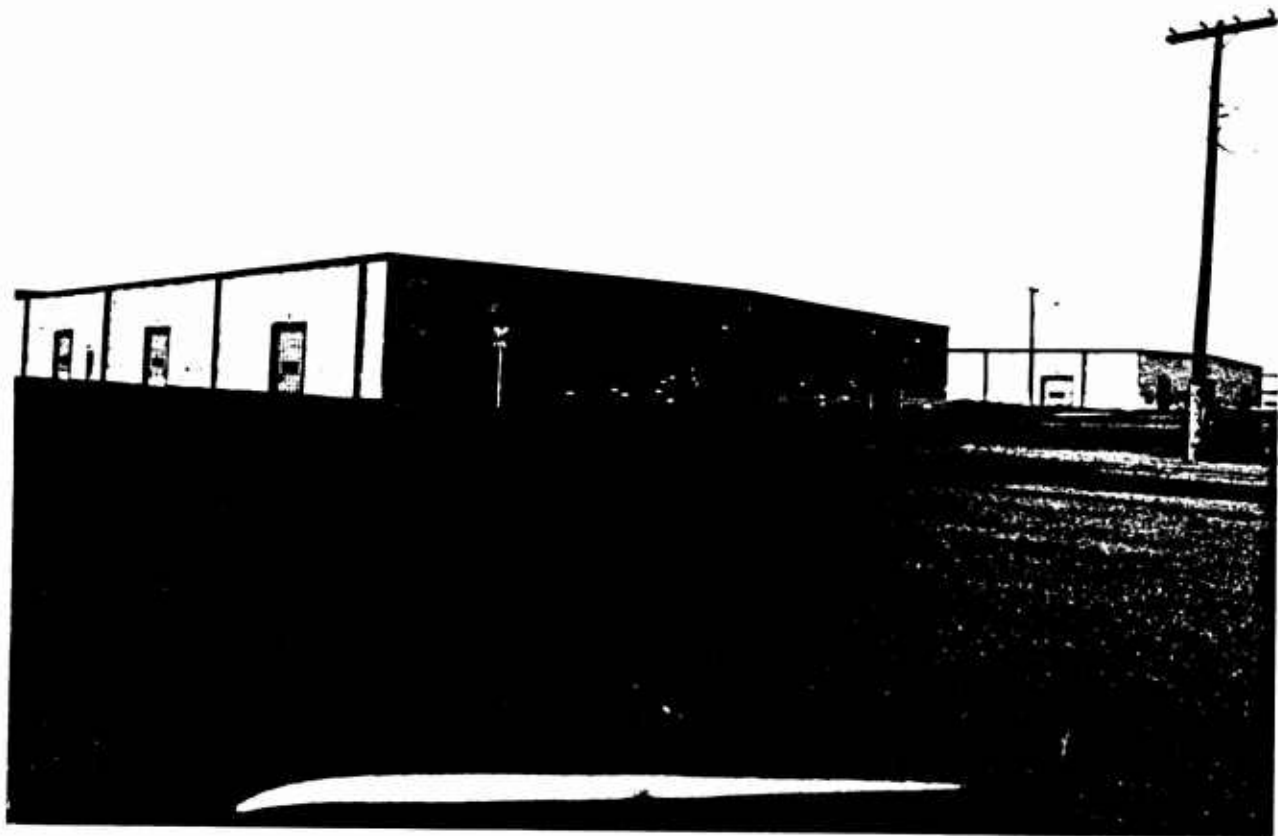
Figure 17: Building 578 is typical of the depot's fourteen structures that were originally constructed as open sheds and converted to enclosed warehouses after World War II. (Source: Field inventory photorgraph, 1983, Jeffrey A. Hess, MacDonald and Mack Partnership.)

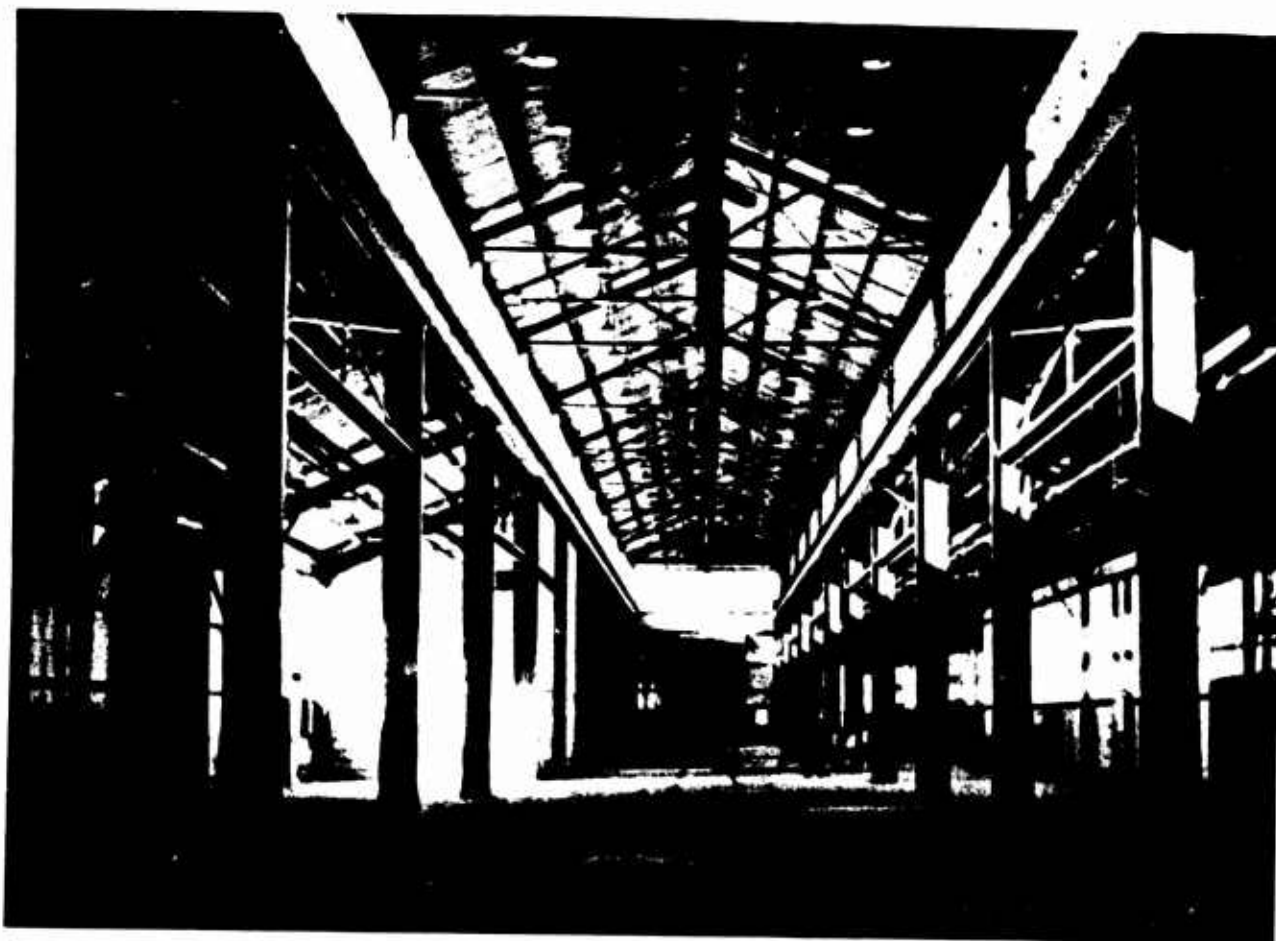
Figure 18: Interior view of Building 547, one of the ordnance repair shops constructed with steel framing. (Source: "Completion Report, Pueblo Ordnance Depot," unpublished report prepared by U. S. Army Corps of Engineers, 1943, PUDA Facilities Engineer's Office.)

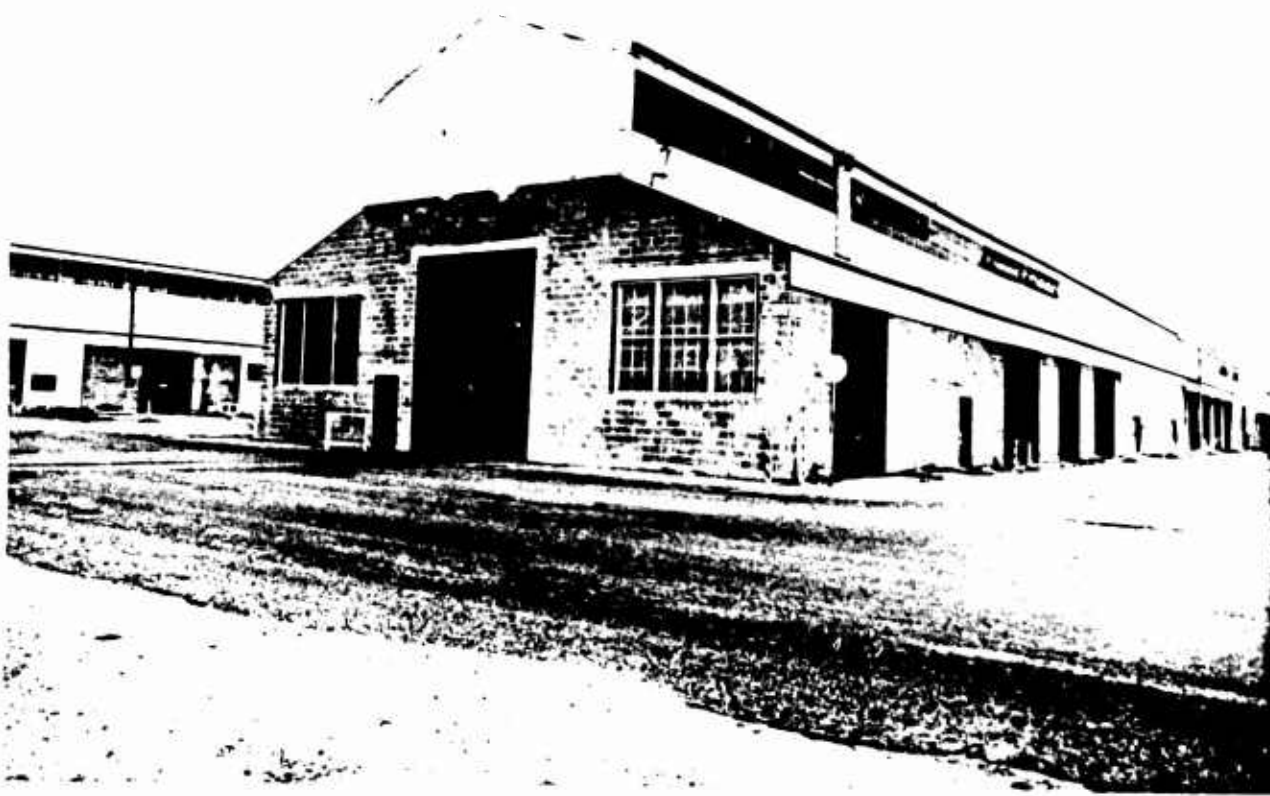
Figure 19: Originally constructed as a general ordnance repair shop, Building 547 was converted into a tank rebuilding facility after World War II. It is currently leased to a private firm. (Source: Field inventory photograph, 1983, Jeffrey A. Hess, MacDonald and Mack Partnership.)

operations by converting several general repair shops (Buildings 547, 548, 550, 551) into artillery shops, which cleaned and packed antitank guns for both overseas shipment and long-term storage (Figure 20).<sup>14</sup> In May 1945, PUDA was designated a tank and combat vehicle repair center, and after V-J Day, the four adjacent artillery shops (Buildings 547, 548, 550, 551) were remodeled into a single H-shaped structure (Building 547) for that purpose.<sup>15</sup>

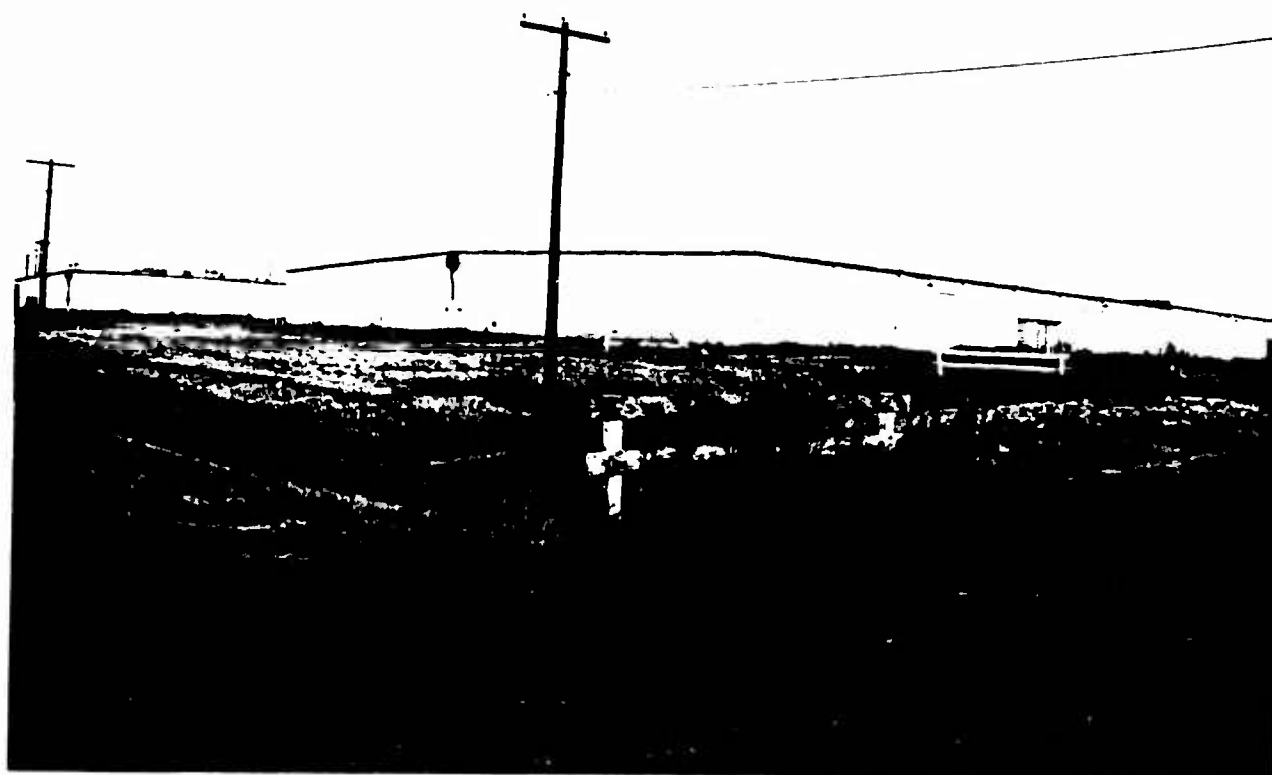
Figure 22: Building 112 is one of three identical warehouses constructed in the early 1950s for the General Services Administration to store critical materials. (Source: Field inventory photograph, 1983, Jeffrey A. Hess, MacDonald and Mack Partnership.)
